**CITY HISTORIC ZONING COMMISSION**  
**STAFF REPORT - CERTIFICATE OF APPROPRIATENESS APPLICATION**

► FILE NO.: 40711FTS

ADDRESS OF PROPERTY: 1416 Forest Ave 37916

**PROJECT REPORT**

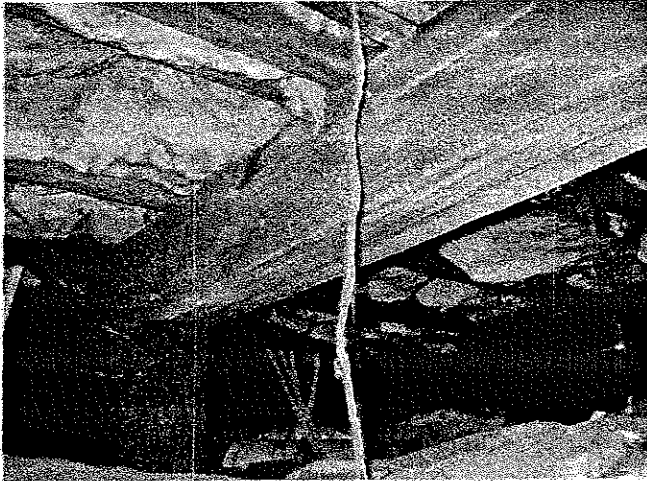
1. Although the floor framing is adequately sized for the floor load, the floors are wavy and sagging.
2. There is standing water in the crawl space. I could see one spot where water is coming into the crawl space through the brick foundation wall. The foundation walls must be excavated, waterproofed, and a foundation drain placed to capture any water that

Floor framing in crawl space.

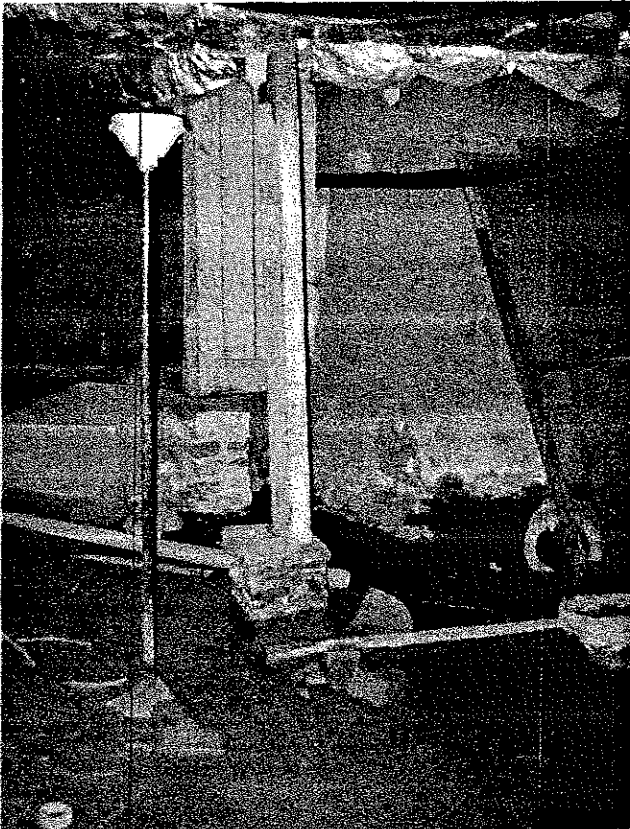
Standing water in crawl space.

percolates to the bottom of the footing. The foundation drain must daylight to discharge any water.

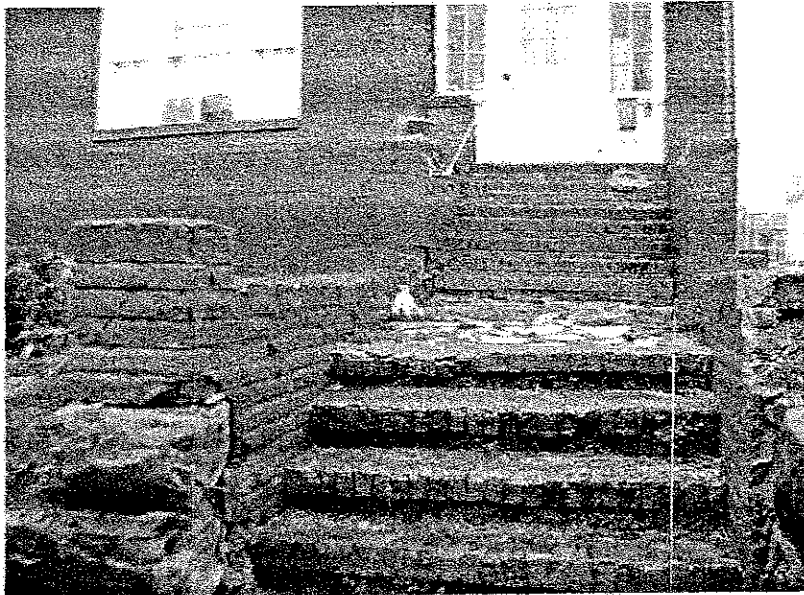
Brick work to be repaired.

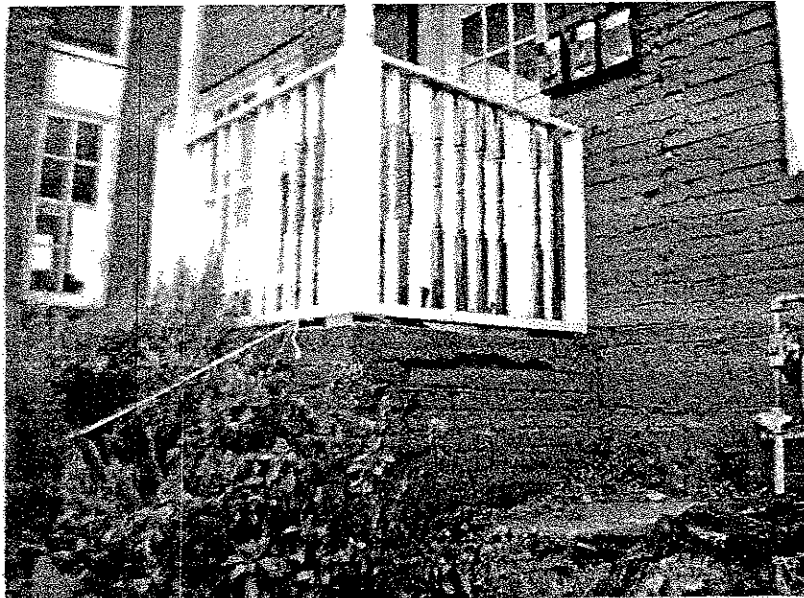
Brick work to be repaired.

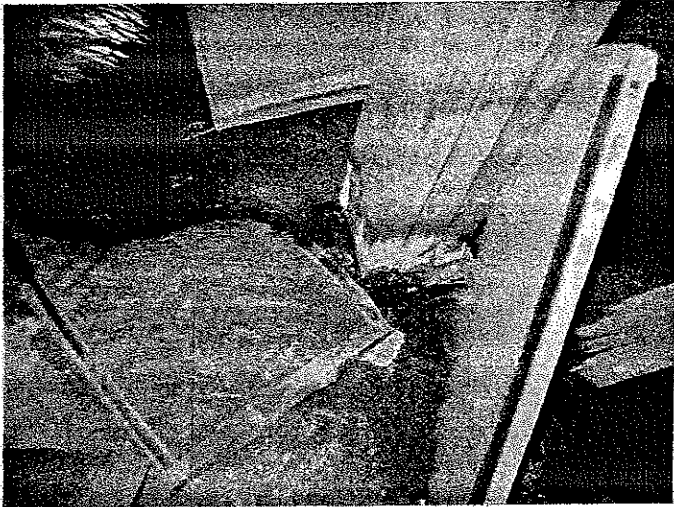
3. The wood posts that support the beams in the crawl space rest on brick or concrete piers. The wood posts do not appear to be pressure treated. This is a code violation that must be remedied by supporting the posts on a metal post base. Also, some posts show sign of water damage; these posts have to be replaced.

Damaged post base.

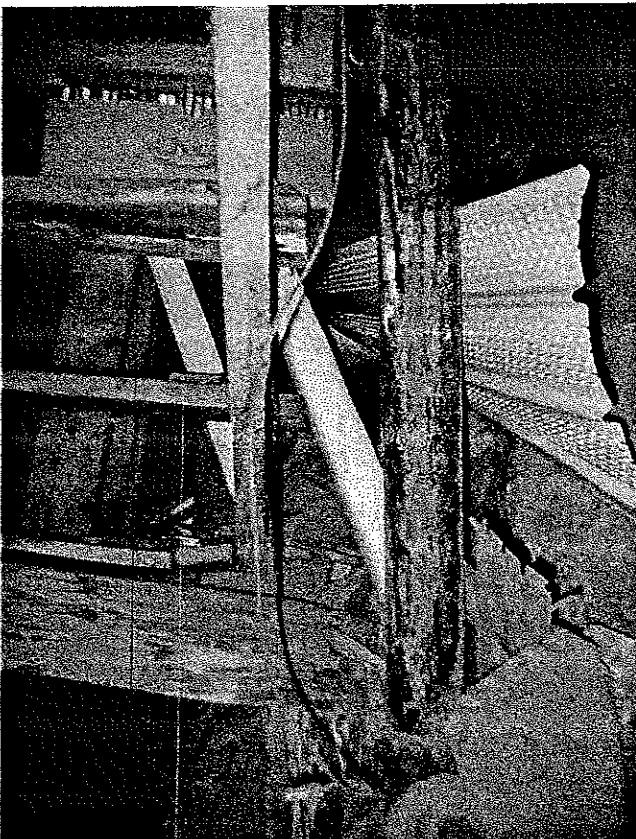
4. From my vantage point in the crawl space, I did not see any structural members that were rotted or in need of replacement, however the stairs to the crawl space must be replaced.

Stairs to crawl space to be replaced.

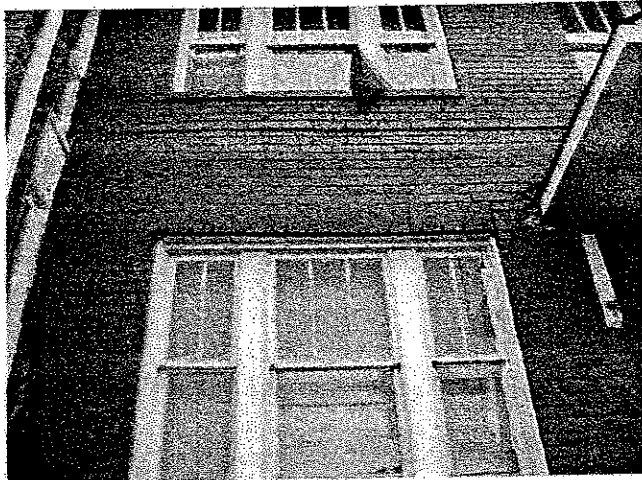
6. There are several window lintels that are sagging and must be repaired to prevent further cracking of the brick.
7. Settlement cracks on the façade where the brick is still near level can be repaired simply by re-pointing the cracked mortar joint with type N mortar. Where the brick is severely out of level, portion of the brick wall must be removed and replaced.

Sagging window lintel

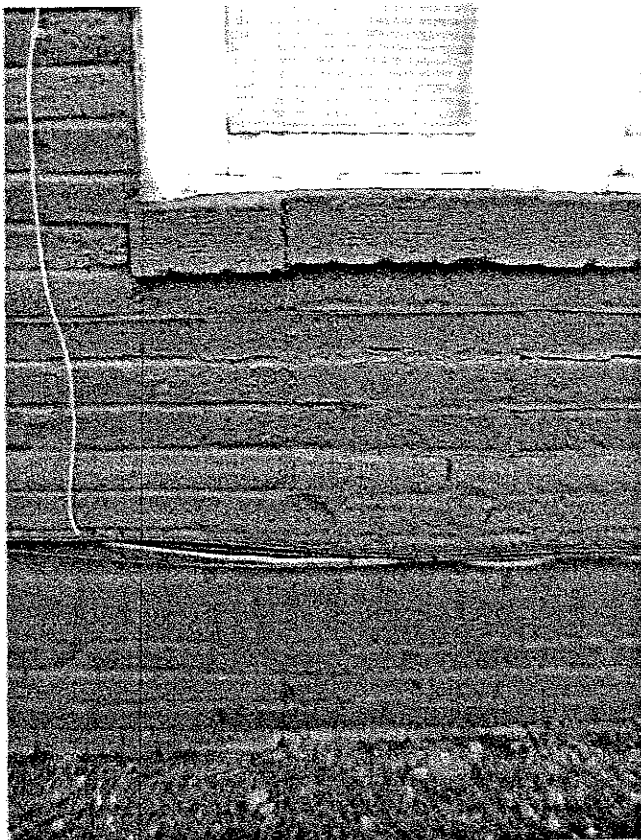
Cracks and settlement of the brick wall.

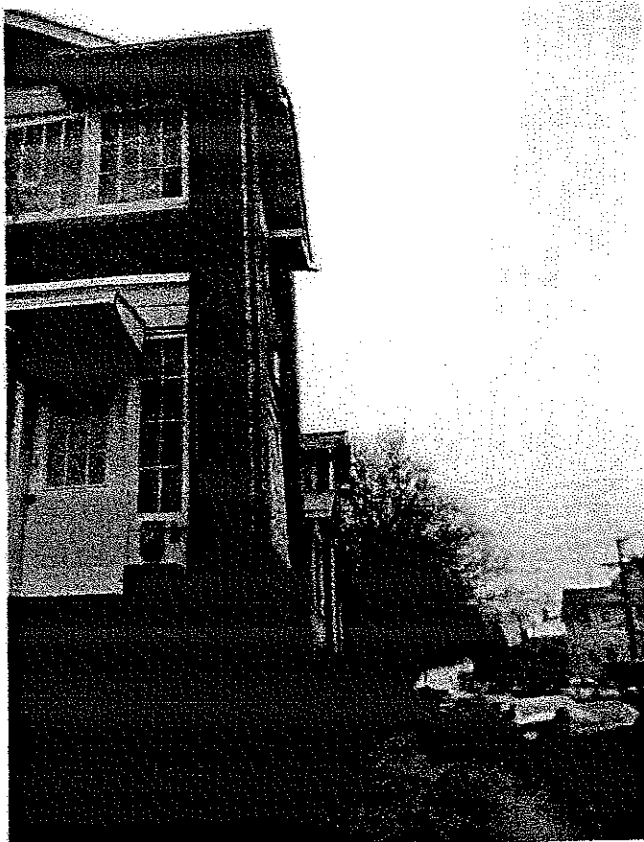
5. The foundation walls on the four sides of the house are rotating and settling. The rotation of the foundation walls is bowing the walls. Rotation may be caused by the lateral pressure imposed on the foundation walls from the exterior. This lateral pressure may originate from the unbalanced fill (exterior grade level higher than the interior crawl space grade level, and by hydrostatic pressure (water in the soil). The foundation walls must be supported against further settlement and rotation. Future settlement may be prevented by providing support to the foundation walls with devices such as Atlas foundation jacks; however the jacks will not prevent rotation. Furthermore the jacks must be spaced at no more than half the height of the foundation wall to ensure proper continuous support (assume 24 inches on center). Future rotation can be prevented by building counterfort walls (wing walls) along the inside of the foundation walls spaced at four to six feet on center.

Item #5 is particularly cumbersome at best if not extremely difficult to execute.

Rotation of the brick wall.

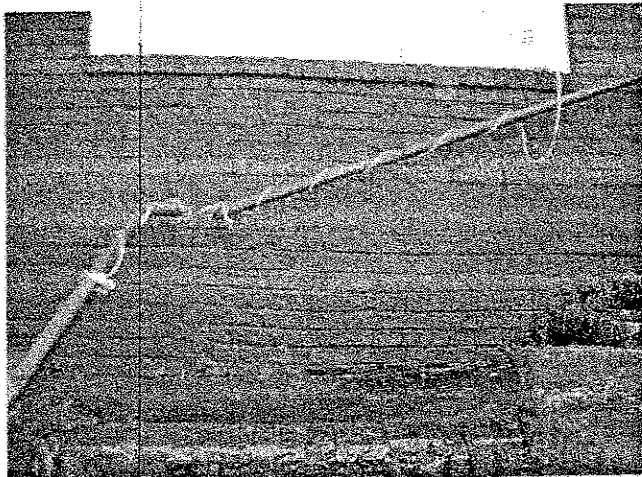
Settlement of the brick wall

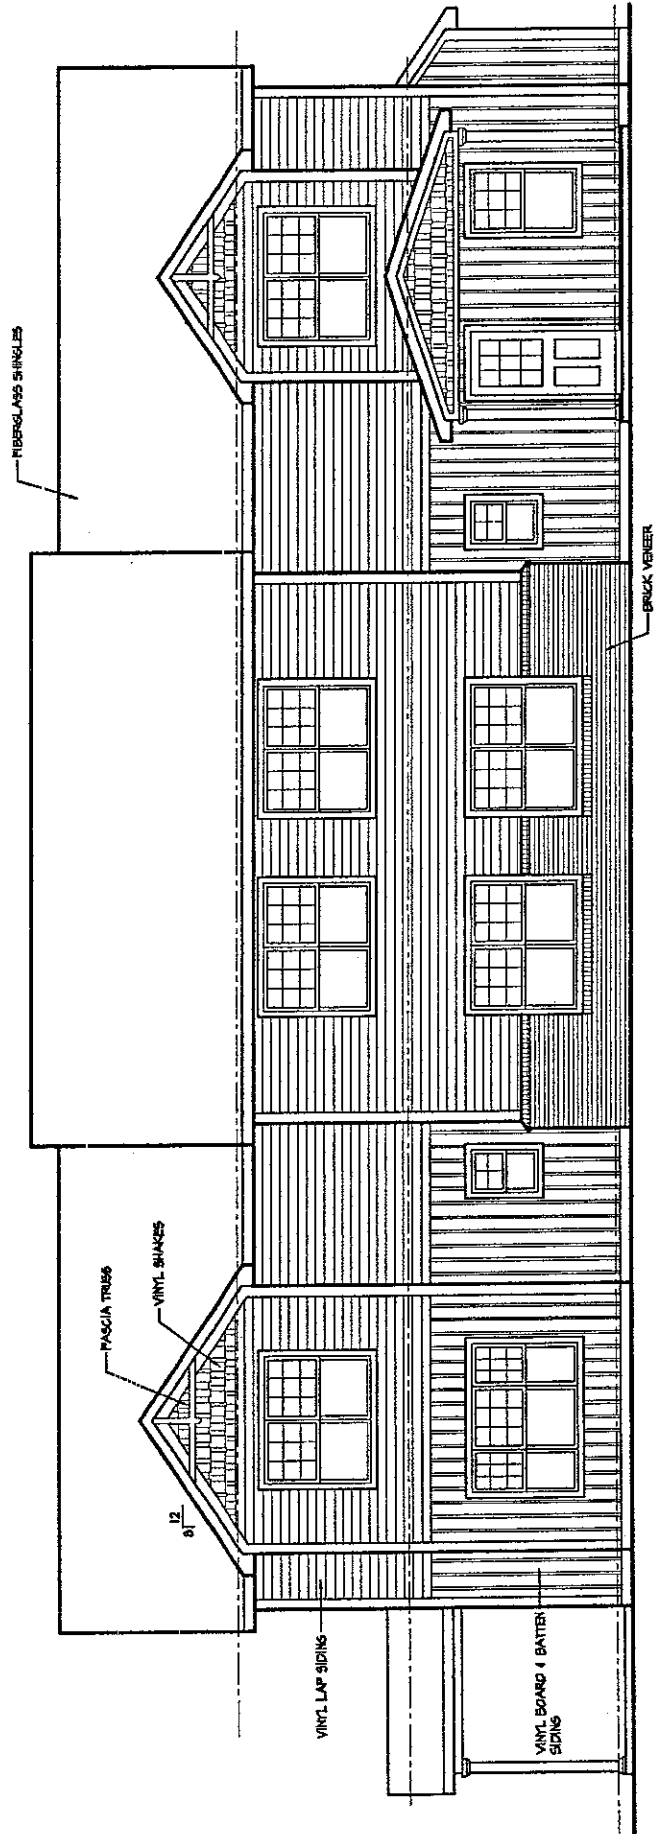
**RIGHT SIDE ELEVATION (FACING JAMES AGEE)**

6) The requirement for bays or porches on the side elevation adjoining James Agee does not appear to have been met. (pgs 17 and 20)

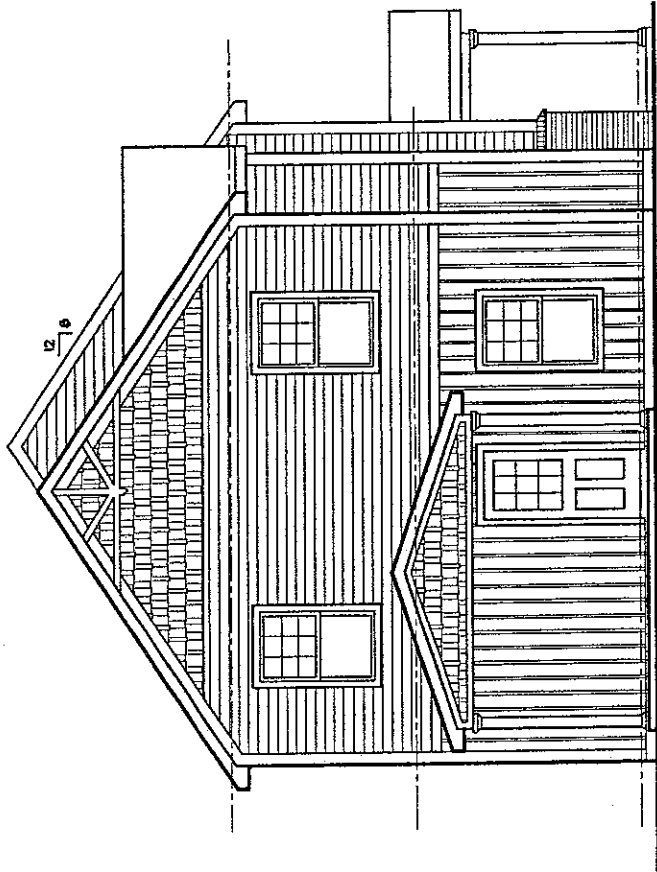
FRONT ELEVATION (FACING FOREST AVE.)

4) There does not appear to be at least 50% transparency on the Forest elevation, or the James Agee. (pg. 10, #8)
